Kepag Longford, Ireland

Draining a wastewater tank in a meat processing facility.

A Tsurumi type 80C21.5 wastewater pump with cutting unit was flange-mounted "dry" on the pipeline.

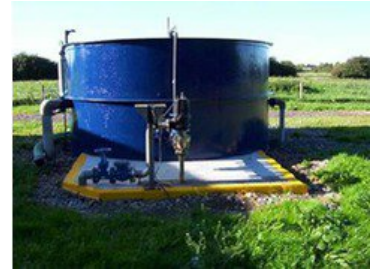
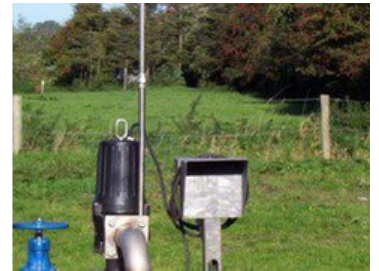
The medium to be pumped itself provides sufficient cooling of the pump.
