## Sewage treatment, apartment building, Croatia

Construction of a new apartment building, Croatia

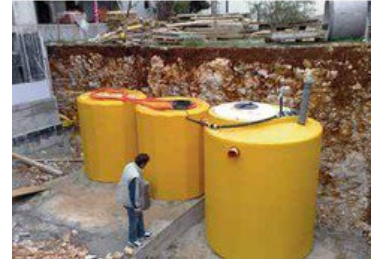
Connection to a small modular sewage works in polyethylene tanks. A Tsurumi submersible aerator with a power of 0.75 kW was fitted in the biological stage of the waste water treatment. The system operates very quietly, with no noise disturbance for the residents.
